**Docket No. 217 – Development and Management Plan Inspection**

Northeast Utilities Service Company Certificate of Environmental Compatibility and Public Need for the construction of a 345-kV electric transmission line and reconstruction of an existing 115-kV electric transmission line between Connecticut Light and Power Company's Plumtree Substation in Bethel, through the towns of Redding, Weston, and Wilton, and to the Norwalk Substation in Norwalk, Connecticut.

**Date:** September 7, 2005

**Location:** 345kV Underground Route

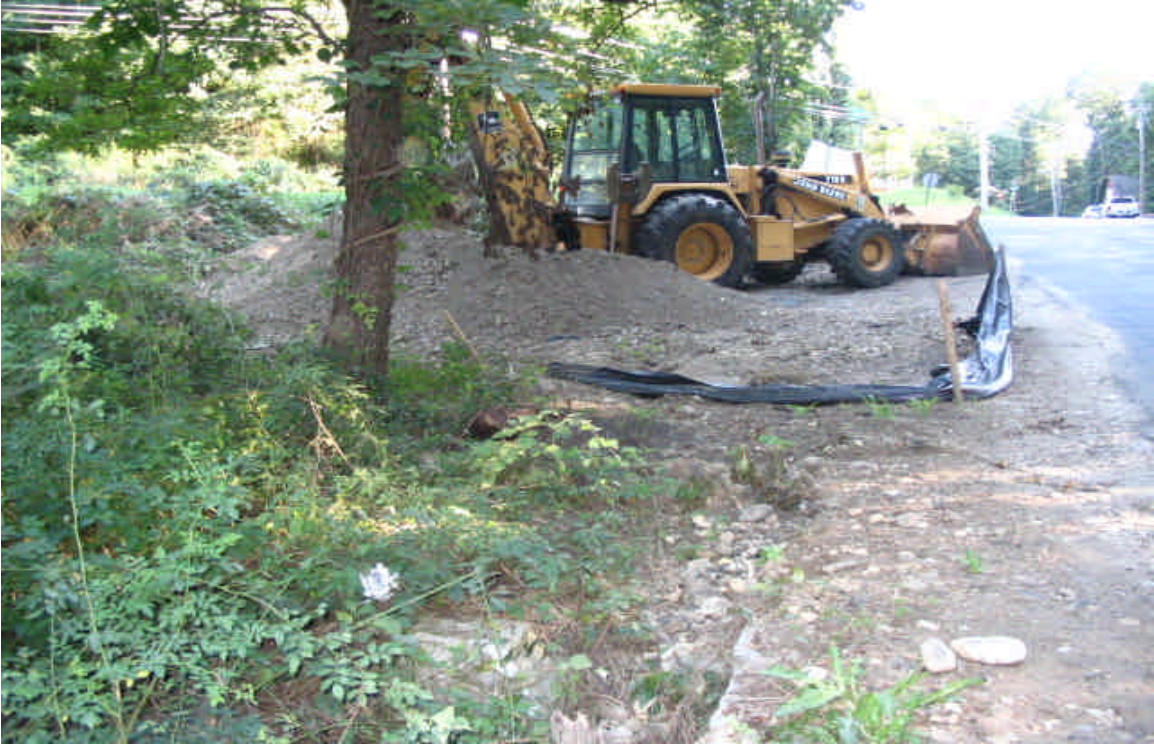
**345kV (Route 107 Daywork): Near Umpawaug Rd. Silt fence was installed near a stockpile but it has fallen down and needs repair. (9/7/05)**

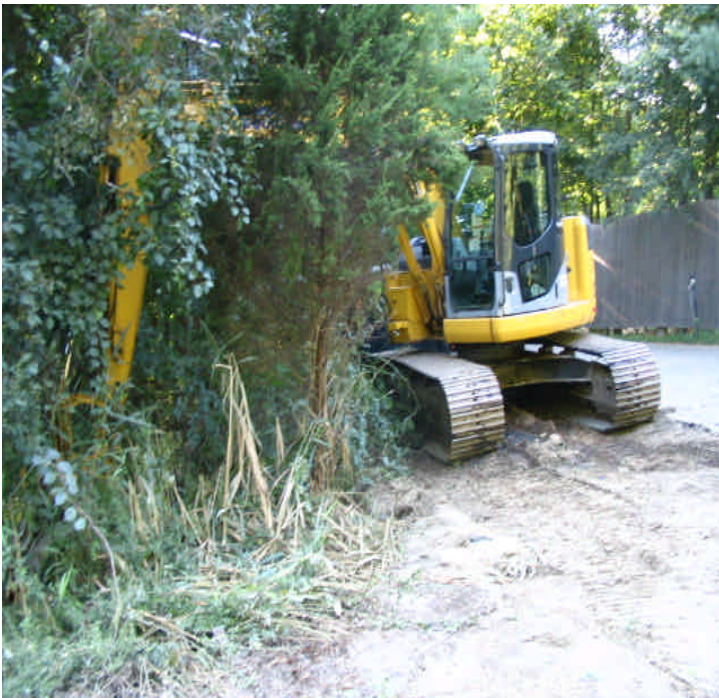
**(North of Georgetown Deli): Photo on the left shows equipment parked off the side of the road, adjacent to a wetland swale. Photo on the right shows a trench box and some equipment which had been placed on top of the silt fence. (9/7/05)**

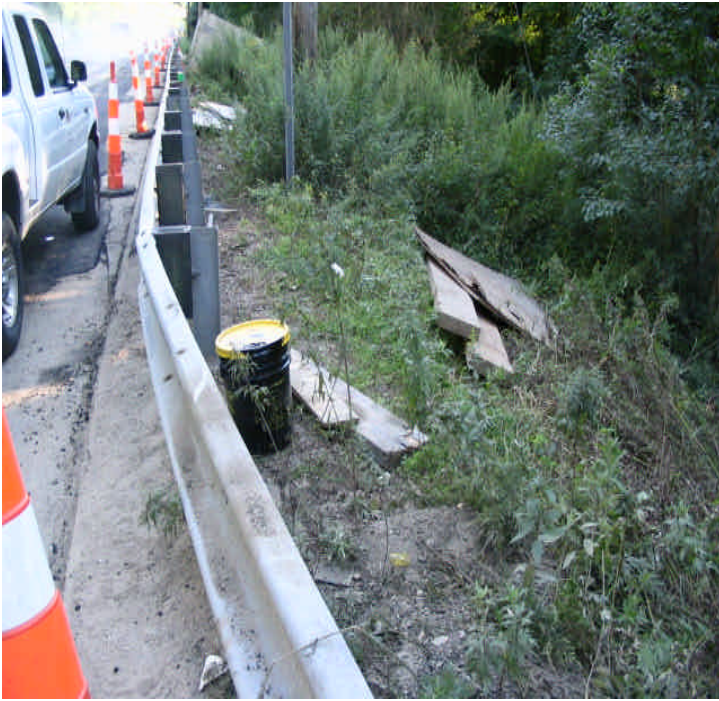
Photo on the left shows some materials left off roadway, including some oil based products and glue containers. Crews were asked to remove these at the end of the day. Photo on the right shows the vicinity where some erosion had occurred under the fence due to roadway runoff. (9/7/05)

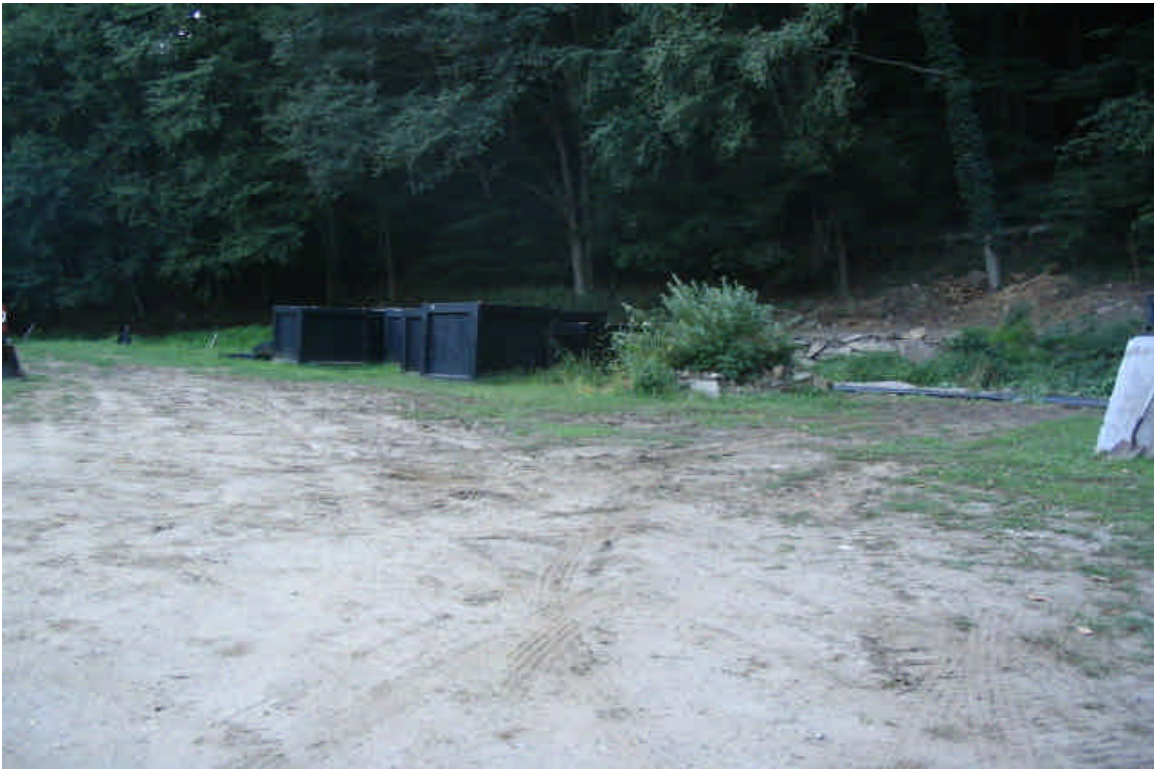
| Areas of Inspection | Observation | Recommended Action |
|--|--|--|
| Erosion and Sediment Controls (includes inspection within 24 hours of a storm event) | <p>- The silt fence located at the edge of the original storage yard near the Rt. 107 and 7 intersection is still down completely, originally due to separate landowner activities. 8/19-9/7/05</p> | <p>-The fence has not been repaired but should be as soon as possible. Wetlands are immediately beyond the yard. 8/19-9/7/05/05</p> |

(345kV: Rt. 7) View of the storage yard near the Rt. 107/7 intersection. Silt fence still needs to be restored following the landowner's activities which pulled it down. (9/7/05)

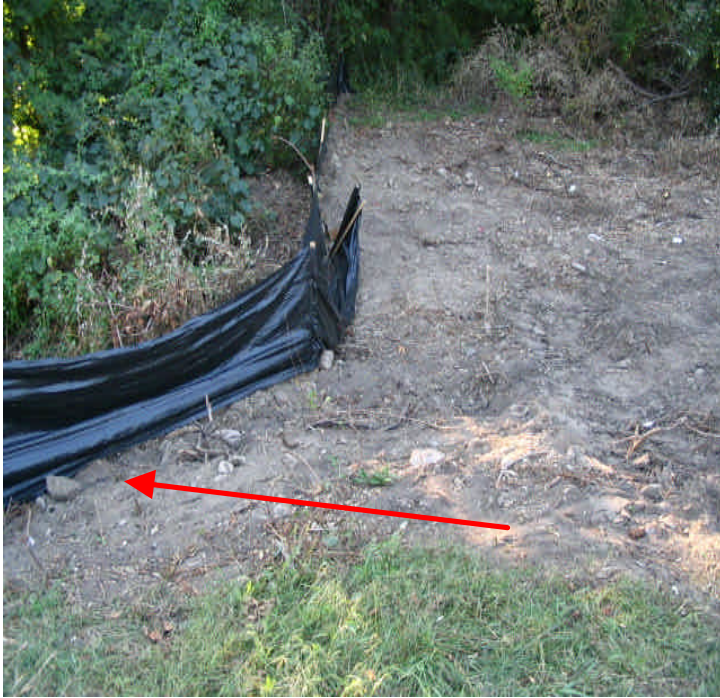
Photo on the left shows the receiving side of the stream jack and bore where vegetation was cleared and silt fence needs some repair/toeing-in. The photo on the right shows where erosion controls on the jacking pit side need repair. (9/7/05)

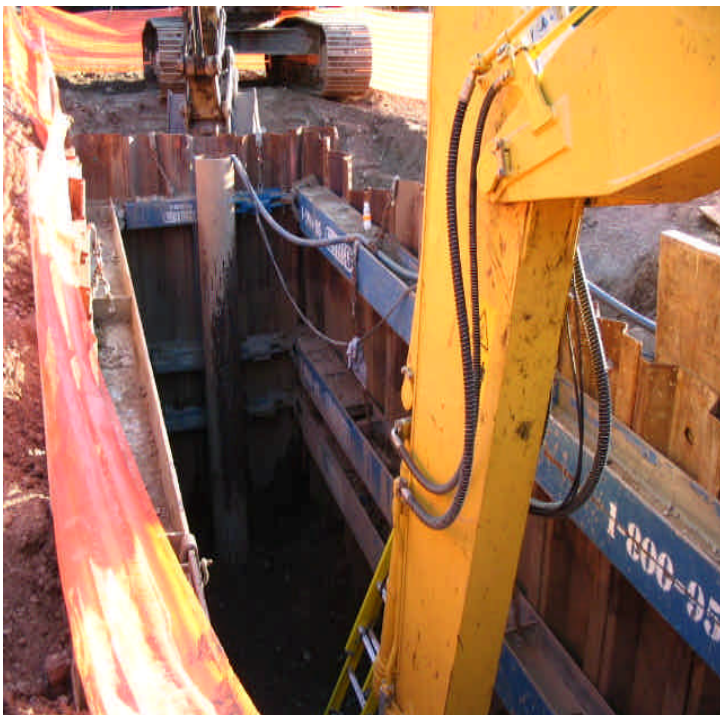
Photo on the left shows a view of the jacking pit which is still active. Photo on the right shows dewatering to the settling basin. Water from the hoses is very clear but the discharge to the stream is still slightly turbid. (9/7/05)

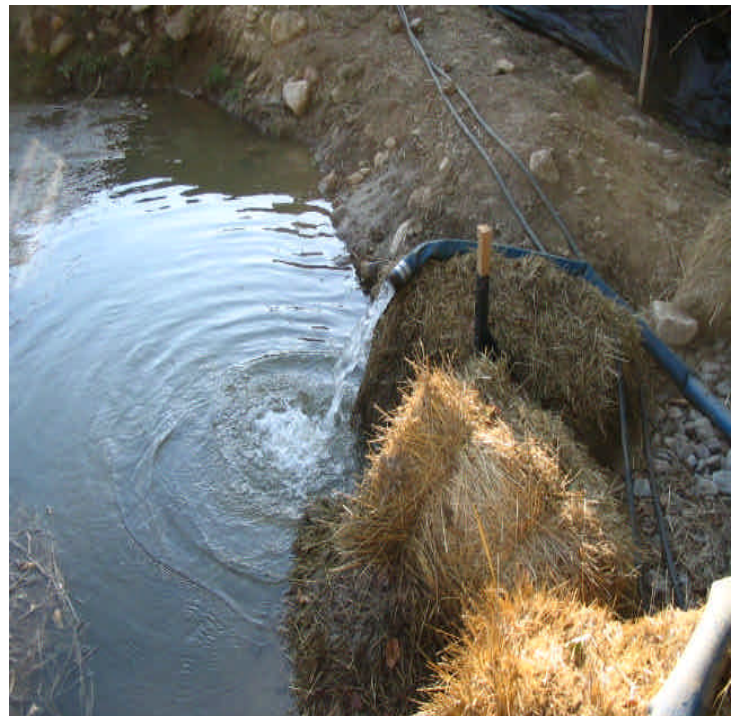
| Areas of Inspection | Observation | Recommended Action |
|--|---|--|
| <p>Adjacent Wetlands and Waterways</p> | <ul style="list-style-type: none"> <li>-The jack and bore near Allens Meadow Park had some slightly turbid discharge from</li> </ul> | <ul style="list-style-type: none"> <li>- Investigate ways to prevent the clear water from accumulating sediment.</li> </ul> |

| Areas of Inspection | Observation | Recommended Action |
|---|---|--|
| | <p>the basin to the stream again during this inspection. Even though the discharge hose water is very clear, it is picking up sediment from the basin itself. 9/7/05</p> <ul style="list-style-type: none"> <li>- Some sediment had been noticed accumulating at the edge of the spillway at the stream's edge. 9/7/05</li> <li>- An excavator was noted parked adjacent to a wetland swale off the roadway. 9/7/05</li> </ul> | <p>9/7/05</p> <ul style="list-style-type: none"> <li>- When the settling basin is removed and closed up, remove the additional sediment accumulation at the edge of the stream by hand/shovel. 9/1-9/7/05</li> <li>- Keep vehicles parked as far from wetland areas as feasible. 9/7/05</li> </ul> |
